August 1, 2023

Re: **Nancy Loud School – Assessment of Southeast Exterior Wall and Foundation**
5 Cocheco Ave
Rochester, NH

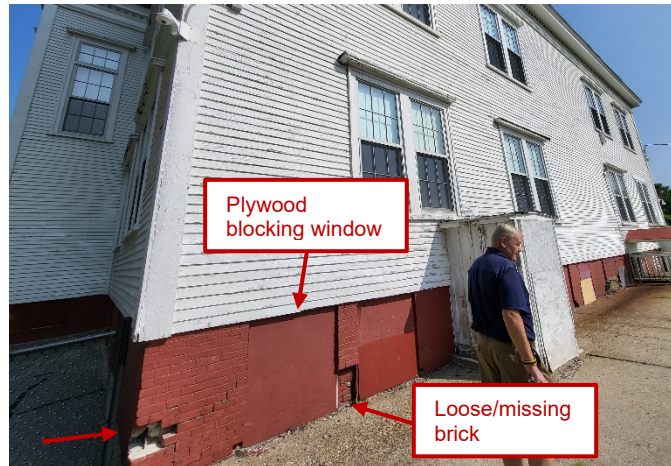
PHOTO 1

- Brick on the exterior side of the west, east, and southeast foundation walls are deteriorated and missing bricks in several locations. There is plywood blocking windows between brick piers along the foundation walls (Photo 1).

The stone and brick foundation walls along the southeast side and a portion of the east side of the building are severely deteriorated (Photos 1, 2, 4, 5, and 6). The outward displacement of the brick foundation walls and exterior wood-framed walls along the southeast exterior wall is consistent with the observed deterioration and loss of brick, stone, and mortar in these walls. It is also possible that foundation settlement is a factor in the observed movement of the foundation walls. Evaluation of settlement and the existing stone foundation walls is outside of our expertise and we understand that you engaged a geotechnical engineer (S.W. Cole) to visit the site on Monday (July 31) to evaluate the condition of the foundation and provide their recommendations. S.W. Cole should also evaluate the depressed slab below the interior partition line to determine if other geotechnical issues need to be considered.

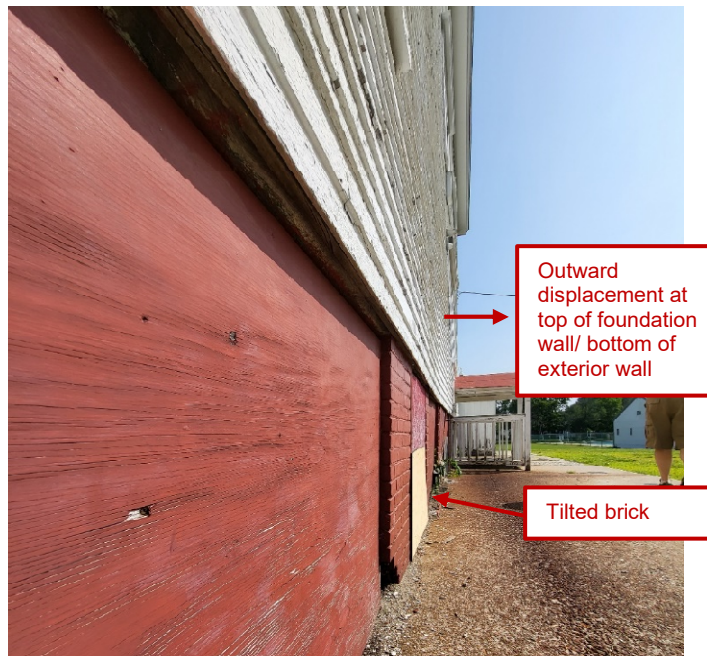
PHOTO 2

- The middle portion of the southeast exterior wall is bulging outward at the top of the foundation wall relative to the rest of the wall. The brick foundation wall piers also appears tilted away from the building (Photo 2).

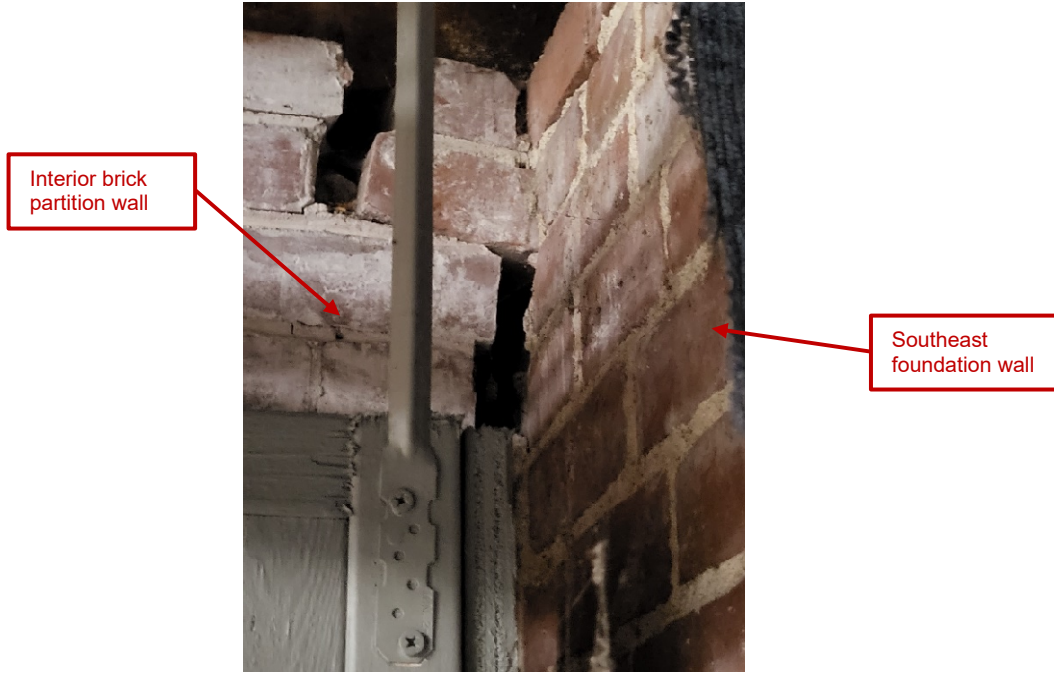
PHOTO 3

- Interior brick partition walls in the basement are separated from the southeast foundation wall by over an inch in some location (Photo 3).
- The foundation wall material transitions from brick to stone below grade. The stone foundation is severely deteriorated and missing mortar along most of the southeast foundation wall (Photo 4) and along the southern portion of the east foundation wall (Photo 5). The stone is loose and has large gaps in many locations (Photos 4 and 5).

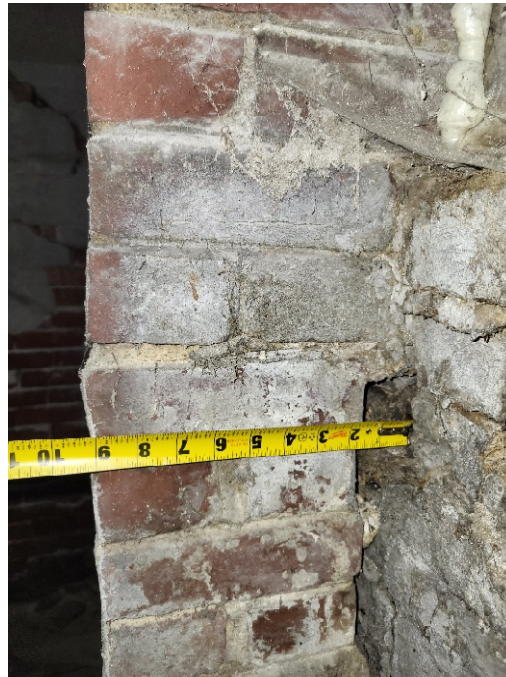
PHOTO 6

- Brick piers are separated from the inside face of the stone foundation walls in many locations (Photo 6).
- A wood perimeter beam appears to bear on top of the southeast foundation wall and support the notched, 2x10 first-floor joists (Photo 7). The 2x10 first-floor joists are no longer bearing on the notched perimeter beam in many locations along the length of the southeast foundation wall (Photos 7 and 8). We could not observe the size and position of the perimeter beam during the site visit.

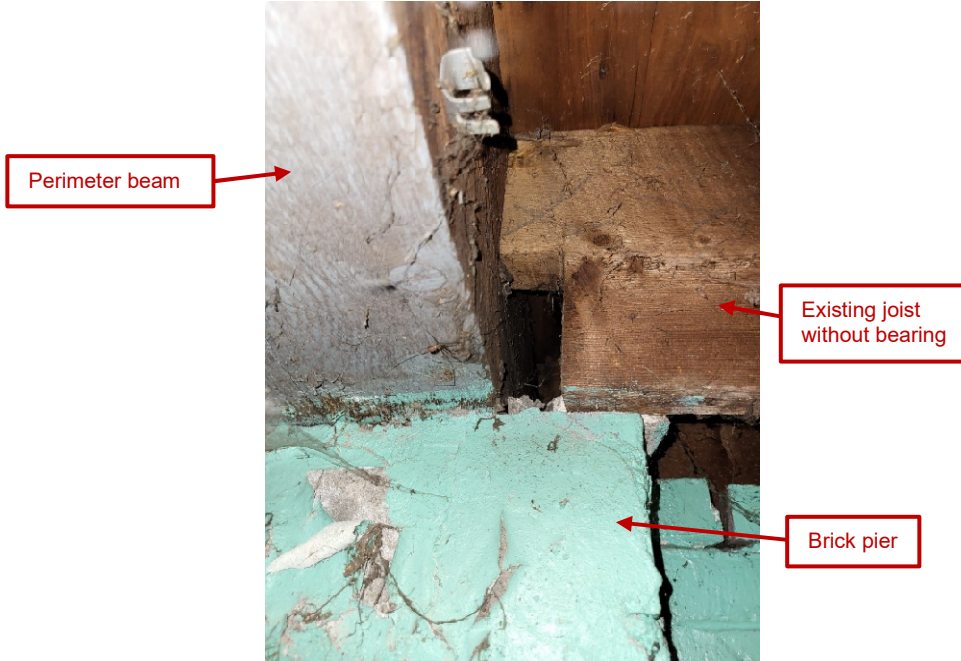
PHOTO 7

Due to the outward movement at the top of the southeast foundation wall, the perimeter beam and exterior wall above are also displaced outward and many of the 2x10 joists supporting the first floor are no longer bearing on the notched perimeter beam (Photos 7 and 8). However, the majority of the 2x10 joists still bear on the ledger attached to the girders along the first interior column line from the southeast exterior wall (Photo 9). Thus, the existing floor joists are effectively cantilevering from the first interior support line toward the exterior wall and are likely only supported by their attachment to the deck. The existing joists are not adequately supported, and this results in an unstable floor construction in this bay. Furthermore, the exterior southeast wall supports a portion of the second floor and roof above. The outward displacement at the bottom of the wall has created a leaning wall which may become unstable if the wall continues to move outward due to further foundation deterioration and movement or if the second floor or roof is loaded beyond the reduced capacity of the wall. The first and second floors are not safe for occupancy due to these deficiencies, and we recommend that the southeast exterior stud wall and first floor joists along the exterior southeast wall be shored prior to reoccupying the building so the existing foundations are not relied upon to support the structure.

- If the school intends to open the building to the students and staff and there is not enough time to make repairs, we recommend installing engineered shoring along the southeast side of the building to support the southeast end of the first-floor joists and exterior wood-framed wall prior to reoccupying the building.

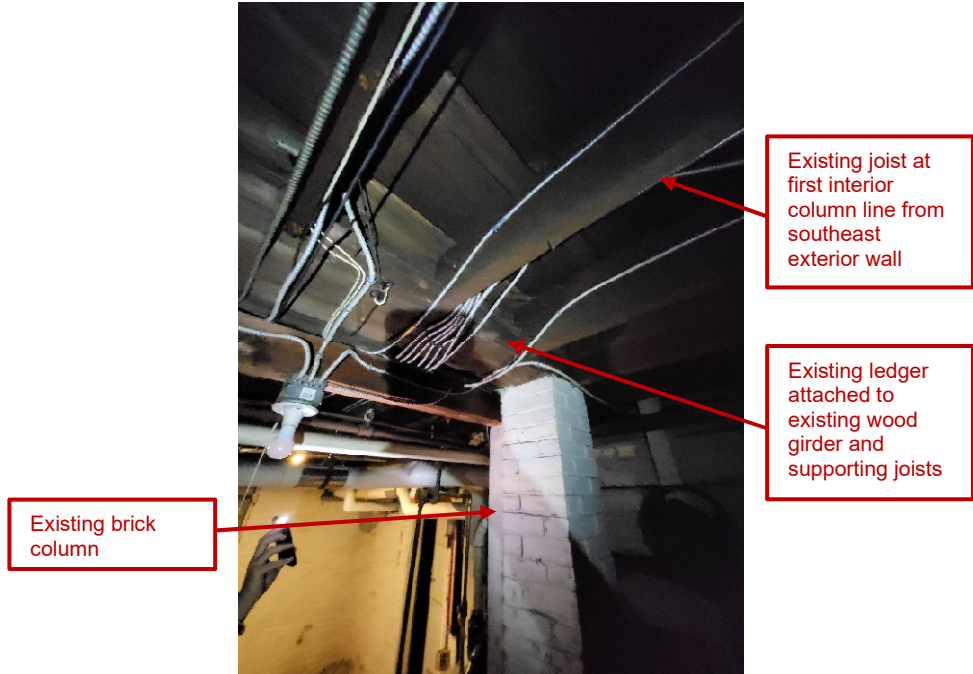
PHOTO 9

- 2x10 first-floor joists at the southeast wall are supported by wood girders bearing on brick columns approximately 15 ft. from the southeast foundation wall. The joists are notched at

this first interior column line and bear on ledgers which are connected to the girders (Photo 9).

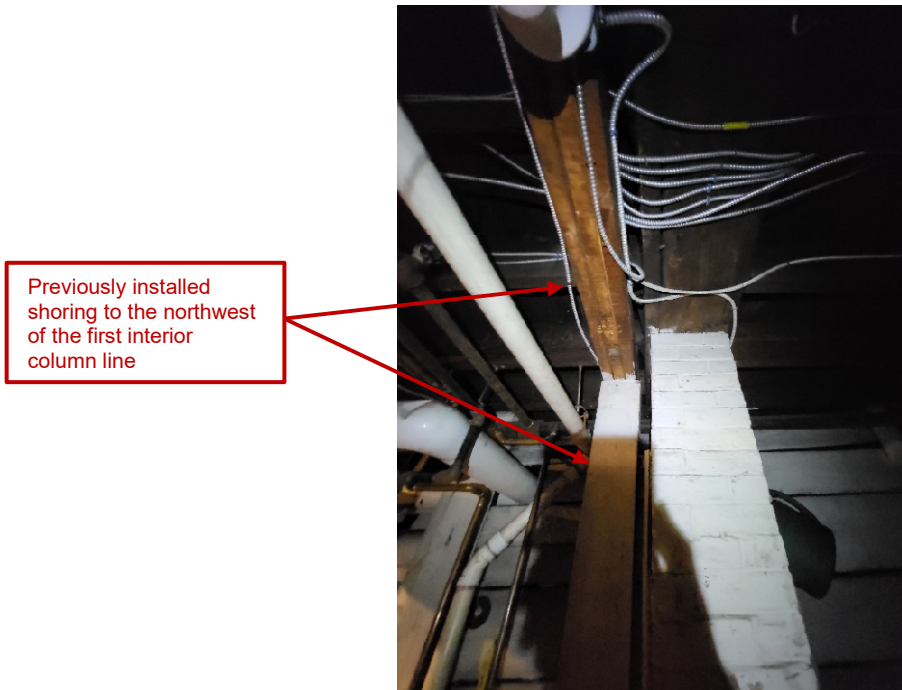
PHOTO 10

- First-floor joists are supported by previously installed shoring to the northwest of the first interior column line from the southeast wall (Photo 10).
- There is a large depression beneath the first partition wall to the west of the east foundation wall (Photo 11). The brick partition wall is not load-bearing.
