23-1529 S

July 31, 2023

Subject: Preliminary Geotechnical Site Assessment  
Nancy Loud Elementary School  
5 Cocheco Avenue  
Rochester, New Hampshire

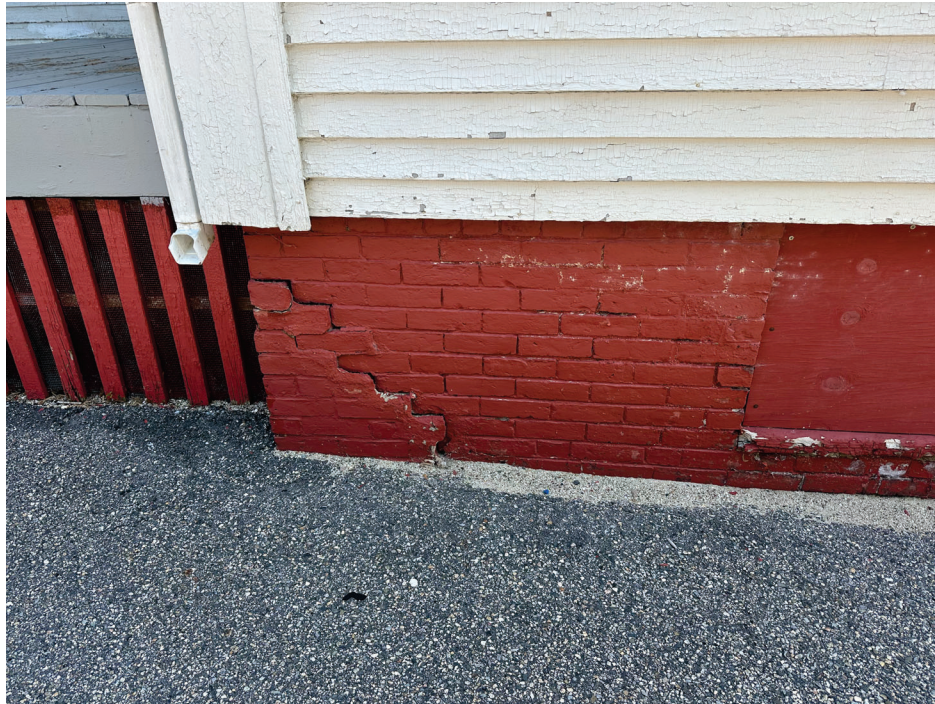
Our site visit began along the exterior of the existing building. Based on our observations, several areas along the southwest and southeast perimeter foundation walls have shown severe displacement and separation of the existing brick structure. There are several voids within the existing walls where bricks have deteriorated and are missing. The existing southeast foundation wall was also observed to bow outward away from the building.

Brick displacement along Southeast perimeter wall

Based on our observations, the separation of foundation and floor joists along the southeast perimeter wall and depression in the central portion of the building indicate soil movement and settlement below existing foundations. The cause of which are not apparent at this time. As evidence of depression widening and brick separation, we anticipate that settlement is ongoing and will continue without remediation efforts. As such, we recommend a site investigation consisting of a combination of test pit and test boring explorations be performed to analyze the subsurface soils for potential causes of foundation distress, and to determine feasible options for foundation remediation.

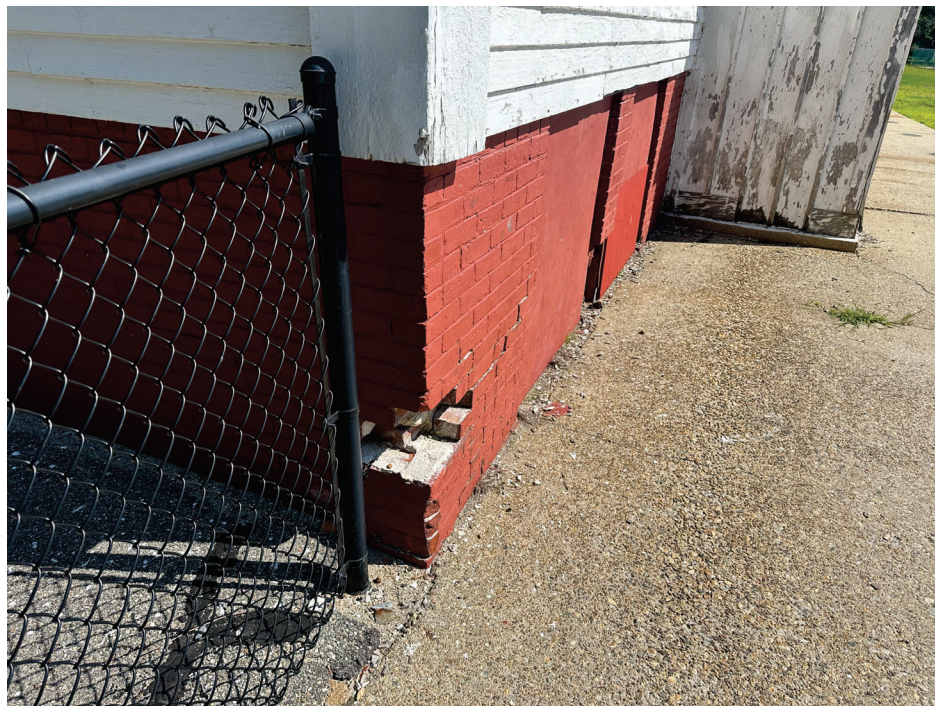
Missing brick on Southern building corner

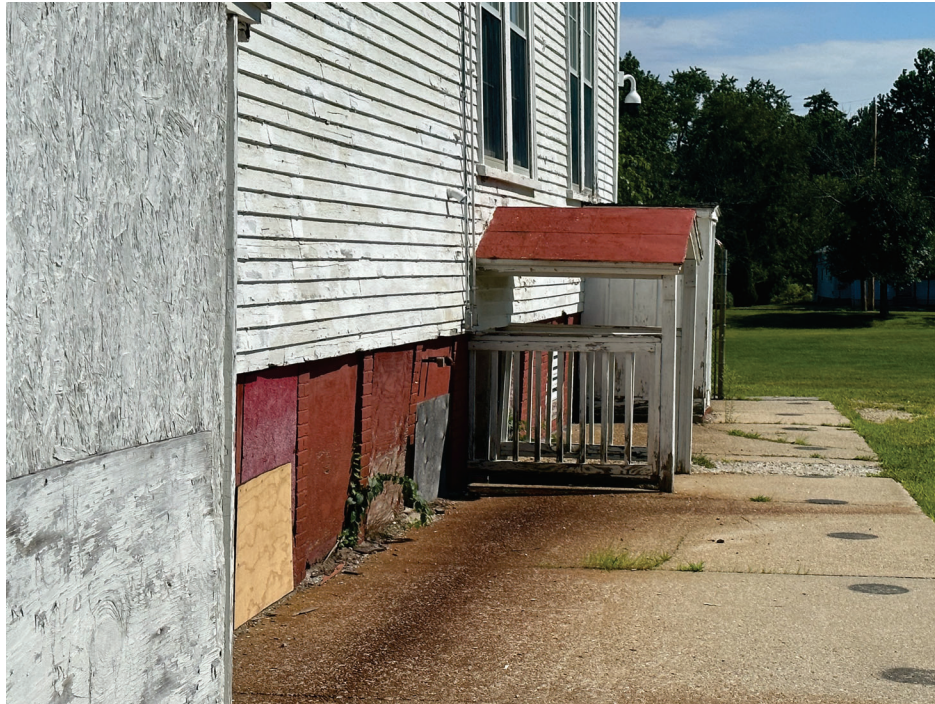
Southeast perimeter wall

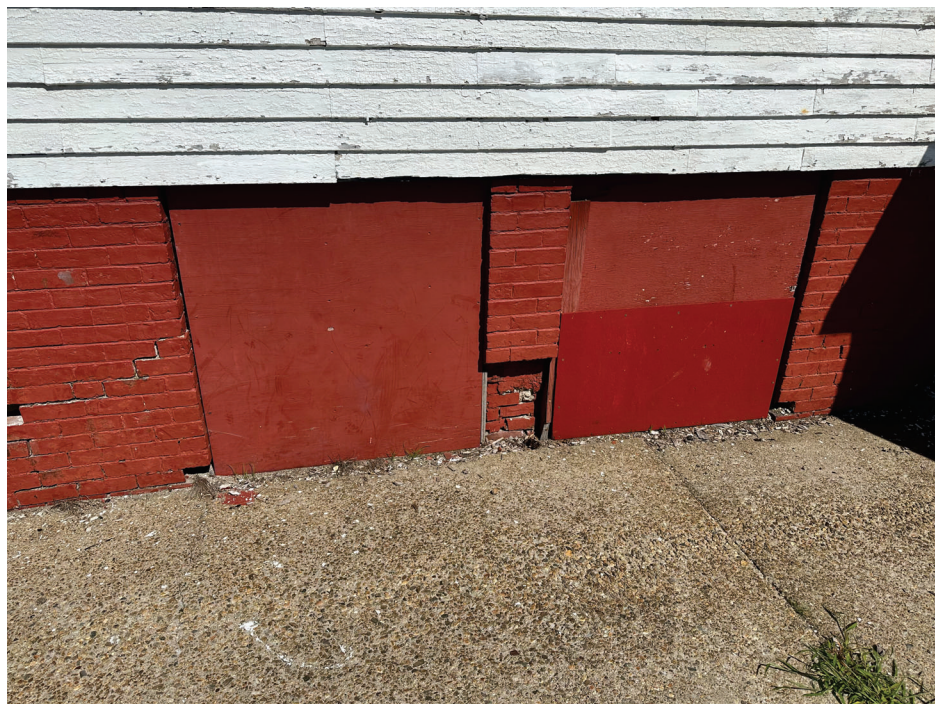
Missing brick and brick displacement along Southeast perimeter wall

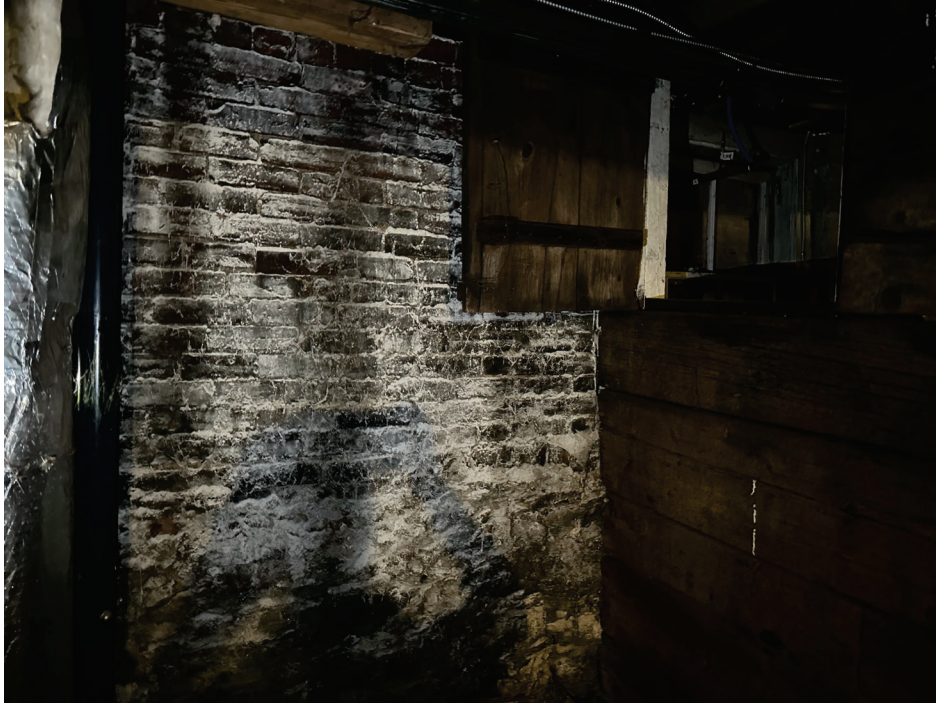
Our site visit then moved to the interior of the building. Observations along the southeast wall coincide with exterior observations where the existing foundation appears to bow away from the building. Based on our observations, the existing floor joists are no longer seated atop the foundation wall. Several areas along the existing perimeter wall showed displacement and separation of the brick and rubble stone structure with some areas missing bricks and stones. Toward the central portion of the building, we observed a depression below an existing firewall. The extents of the depression appear to be encroaching toward existing load bearing columns. Based on correspondence with you, we understand this area pools stormwater and has been growing wider over the past several years.

Interior view of Southeast perimeter wall

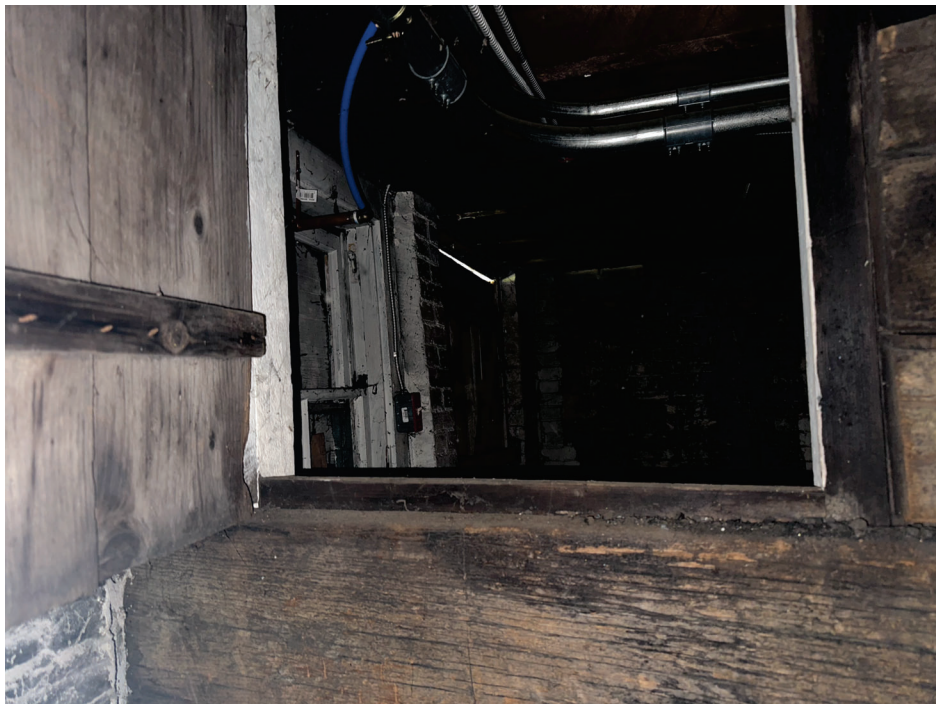
Floor joists along Southeast perimeter wall

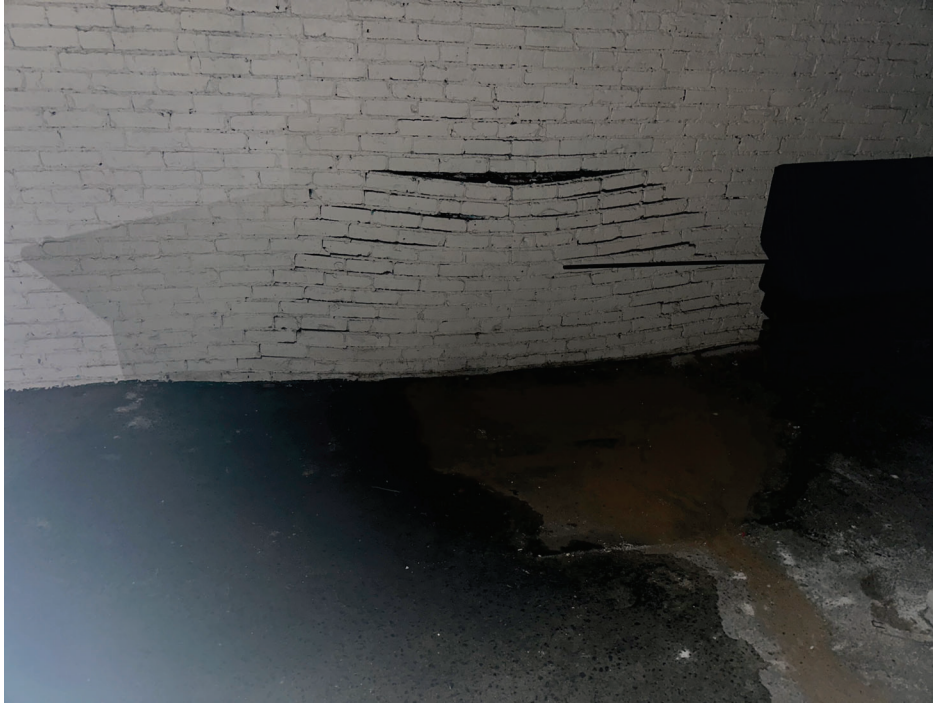
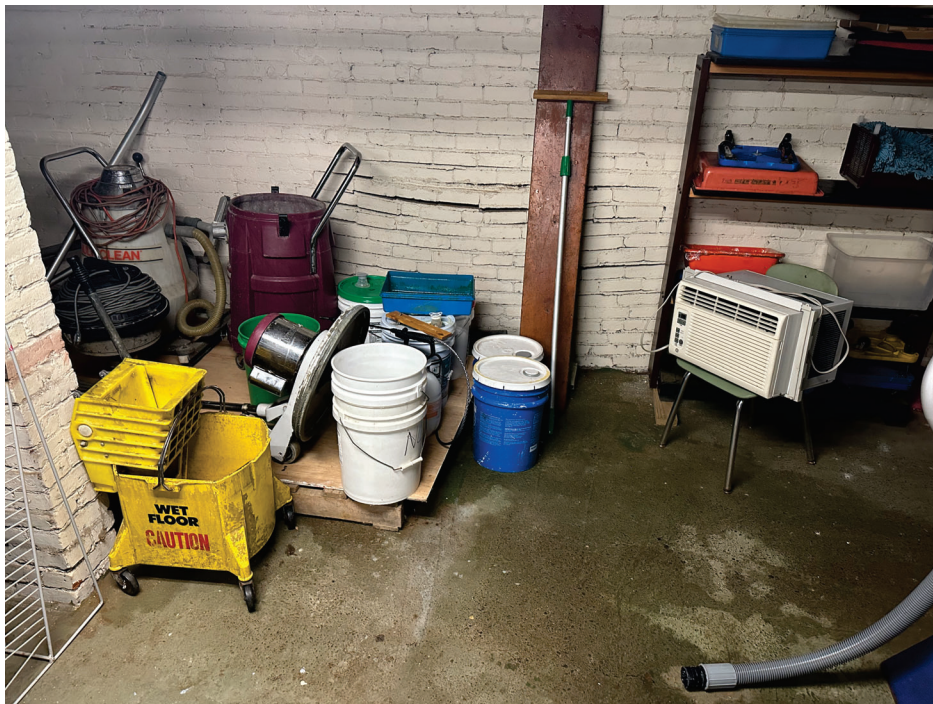
Depression and brick displacement in central portion of building
