August 1, 2023

Re: **Nancy Loud School – Assessment of Southeast Exterior Wall and Foundation**
5 Cocheco Ave
Rochester, NH

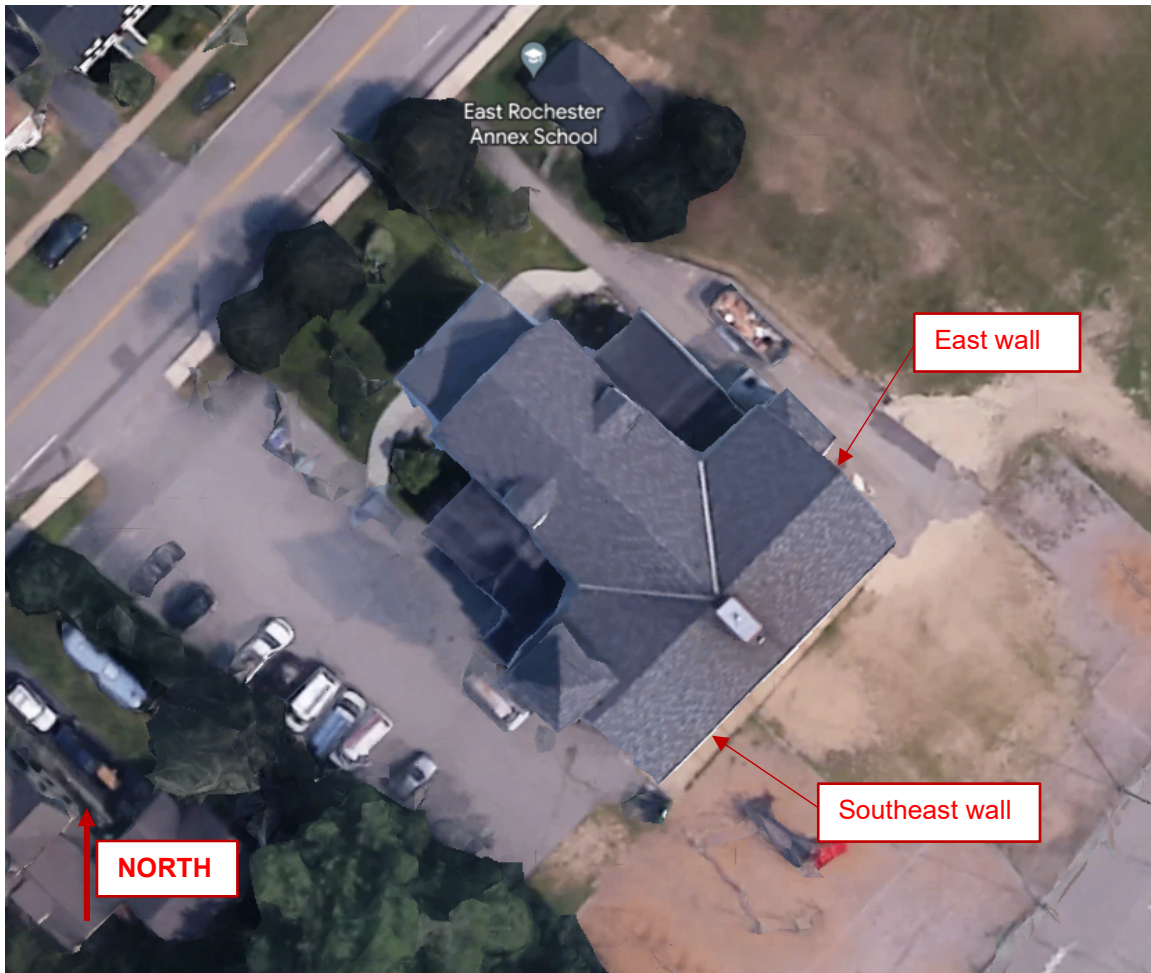
FIGURE 1
(Image by Google Earth)

The Nancy Loud School was constructed in 1880 and consists of one main two-story building with a gabled roof and bell tower, an auxiliary two-story section with a lower roof on the northwest side, and two auxiliary one-story sections to the northeast and southwest sides of the building (Figure 1).

Our observations are based on what we could observe firsthand. The wall exterior wall assembly, bottom of wall construction and attachment to foundation wall, and second-floor framing are concealed so direct observations of these components was not possible. For the purposes of identifying locations in this report, true north is identified in Figure 1 and the southeast and east walls are labeled for clarity.
